**Roof Hail Distress Evaluation
of Multiple Structures**

18559.0, 18559.01, 18559.02, 18559.03

CIRSA Wheat Ridge
Multiple Structures
Wheat Ridge, Colorado 80033

July 19, 2017

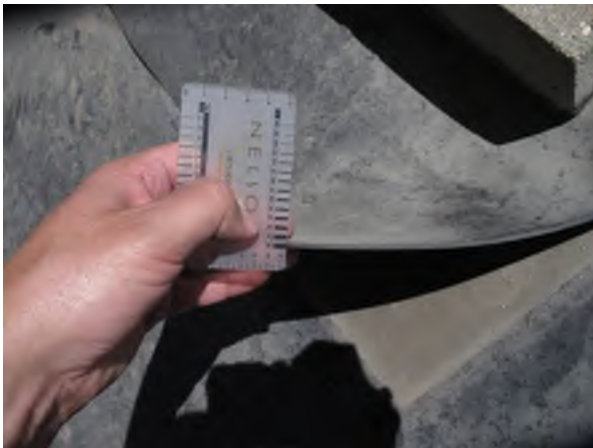
- ❑ Measured membrane thickness of 90 mil (0.090") at the lower roof section, and a manufacturer's label indicating a membrane thickness of 60 mil at the upper roof section (**Figures 6 – 7**);
- ❑ Burnish marks measuring up to 1-1/2" in diameter on the south-facing metal roof panels (**Figure 8**);
- ❑ Indentations measuring up to 1-1/2" in diameter on the light-gauge metal vent covers (**Figure 9**);
- ❑ Indentations measuring up to 1" in diameter in the parapet coping and south-facing window sills (**Figure 10**);
- ❑ Burnish marks measuring up to 1-1/2" in diameter on the membrane with coincident softness and/or bruising of the substrate at both the upper and lower roof sections (**Figure 11**).

Figure 6: 90 mil membrane thickness at lower roof section

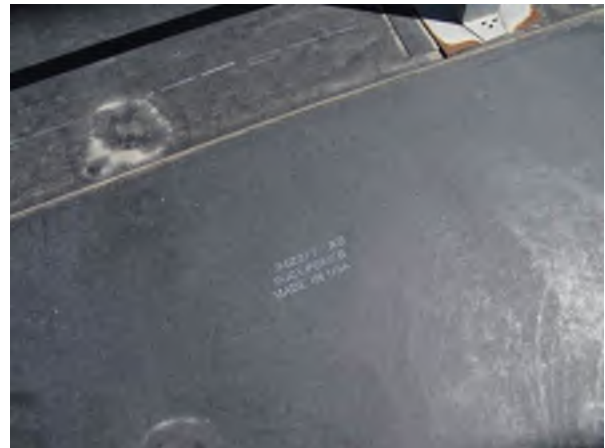
Figure 7: Label indicating 60 mil membrane thickness at upper roof section

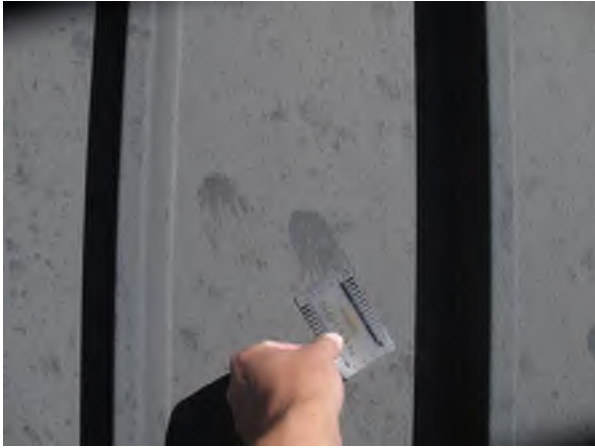
Figure 8: 1-1/2" burnish mark on south facing metal roof panels

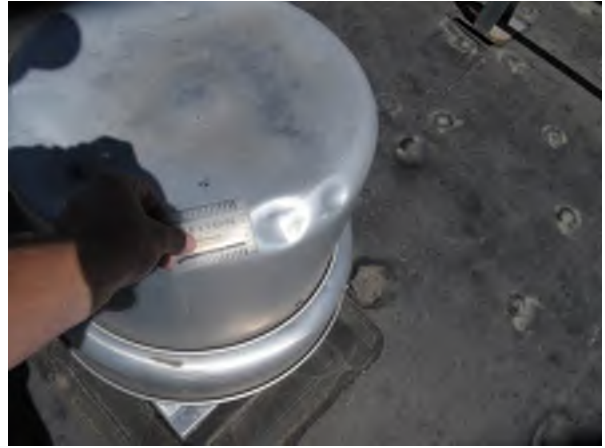
Figure 9: 1-1/2" diameter indentation in metal vent cover

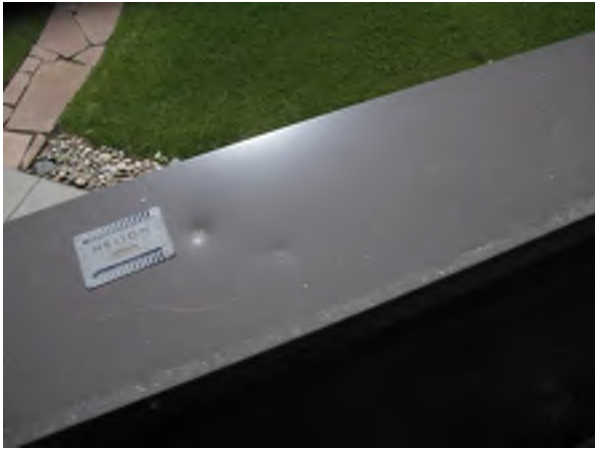
Figure 10: 1" diameter indentation in metal parapet coping

- Remove and Replace the fully-adhered EPDM roof systems down to the roof deck, to include parapet coping (which will likely be damaged during removal of the existing roof systems).

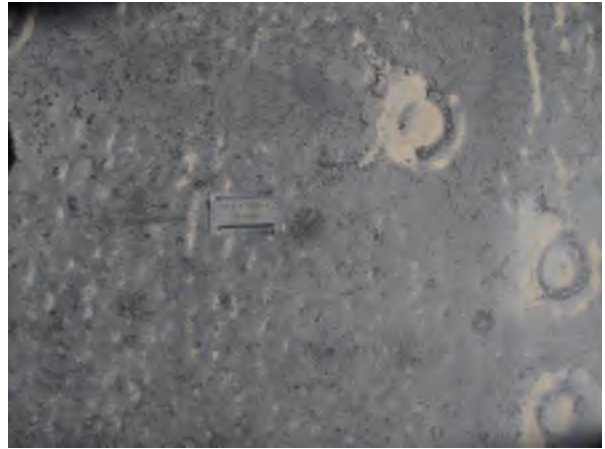
Figure 11: 1-1/2" diameter burnish mark on membrane at lower roof section

In Nelson's opinion, the weatherproofing function of the EPDM membrane roof sections has not been damaged by hail impact; however, hail impact has damaged the gypsum board substrate such that it is no longer suitable for attachment of this fully-adhered EPDM roof system. The gypsum board was indented and crushed below the locations of burnish marks and the facer material was fractured and/or separated, indicating that they are the result of hail impact. The indentations and separated facer material have decreased the perpendicular tensile strength, and therefore have decreased the wind uplift resistance of the roof assembly. Given the size and density of the burnish marks, Nelson estimates up to a 10% reduction in the adherence to the substrate, with a corresponding reduction in wind uplift capacity, and therefore the EPDM roof sections should be replaced.

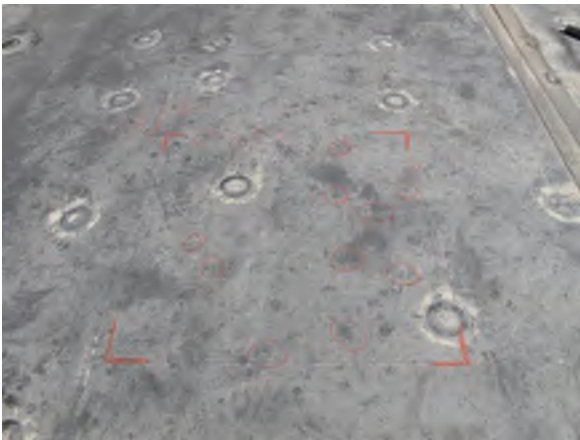
2'x2' Sample Area	Building	Area Surveyed	Areas of Identified Distress
SA #1	City Hall	4 ft. ²	15
SA #2	City Hall	4 ft. ²	14

Figure 33: Overall view of 2'x2' sample area 1 on lower roof section of City Hall

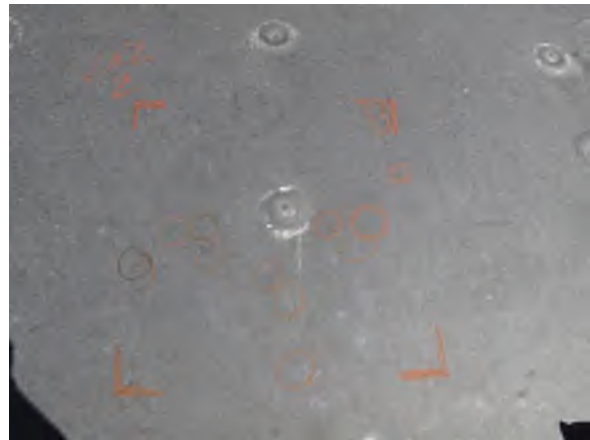
Figure 34: Overall view of 2'x2' sample area 2 on upper roof section of City Hall
