**Roof Hail Distress Evaluation
of Multiple Structures**

18559.0, 18559.01, 18559.02, 18559.03

CIRSA Wheat Ridge
Multiple Structures
Wheat Ridge, Colorado 80033

July 19, 2017

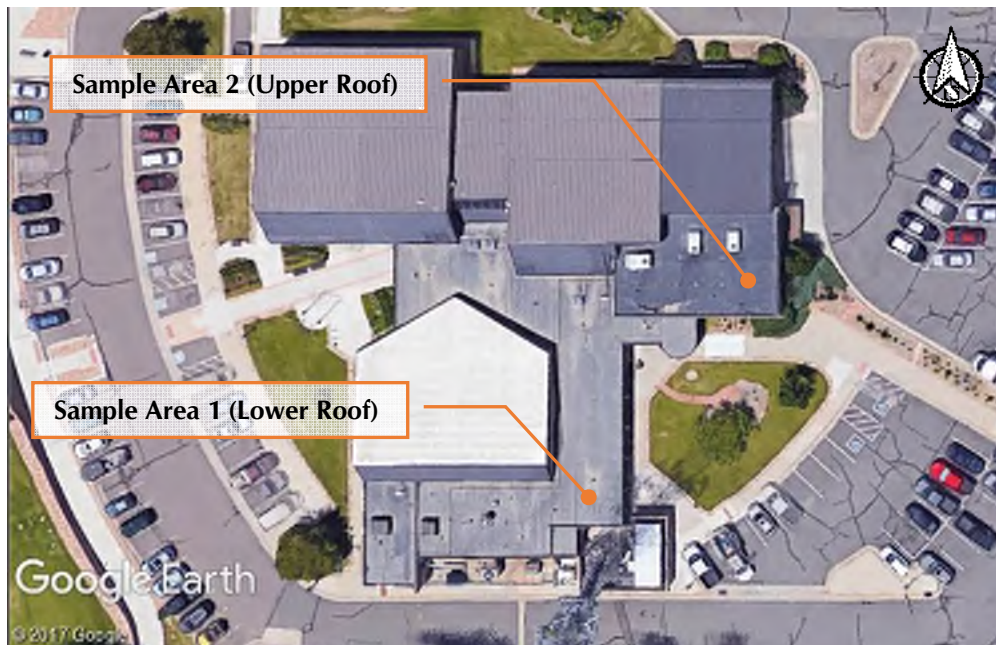
Figure 30: Approximate locations of sample areas at City Hall (Google, Inc. 2017)

Nelson performed a condition survey to quantify the extent of hail impact, if any, to the EPDM (not ballasted only) and thermoplastic roofing. Nelson selected and evaluated seven (7) representative 2'x2' sample areas at the roofs of the subject structures. The sample areas were selected away from parapet walls or mechanical units which could have potentially shielded the roof surface from hail impact. The approximate locations of the sample areas are indicated on **Figures 30 – 32**. The sample areas were chosen to represent the general condition of the roof membranes.

Within each 2'x2' sample area, the roof was evaluated for indentations or depressions in the membrane substrate coincident with burnish marks on the membrane. The purpose of the evaluation was to identify locations on the membrane which were struck by hailstones, to quantify the density of potential distress to the substrate, and to visually evaluate the adhesion of the membrane to the substrate at the sample locations. Representative photographs of the sample areas are shown in **Figures 33 – 39**. **Table 2**, below, lists the representative 2'x2' sample areas and summarizes the observed indentations/depressions which were potentially consistent with hailstone impact.
